TECHNICAL REPORT GL-81-2

15 MILE ROAD/EDISON CORRIDOR SEWER TUNNEL FAILURE STUDY DETROIT AREA, MICHIGAN

Geotechnical Laboratory
U. S. Army Engineer Waterways Experiment Station
P. O. Box 631, Vicksburg, Miss. 39180

January 1981

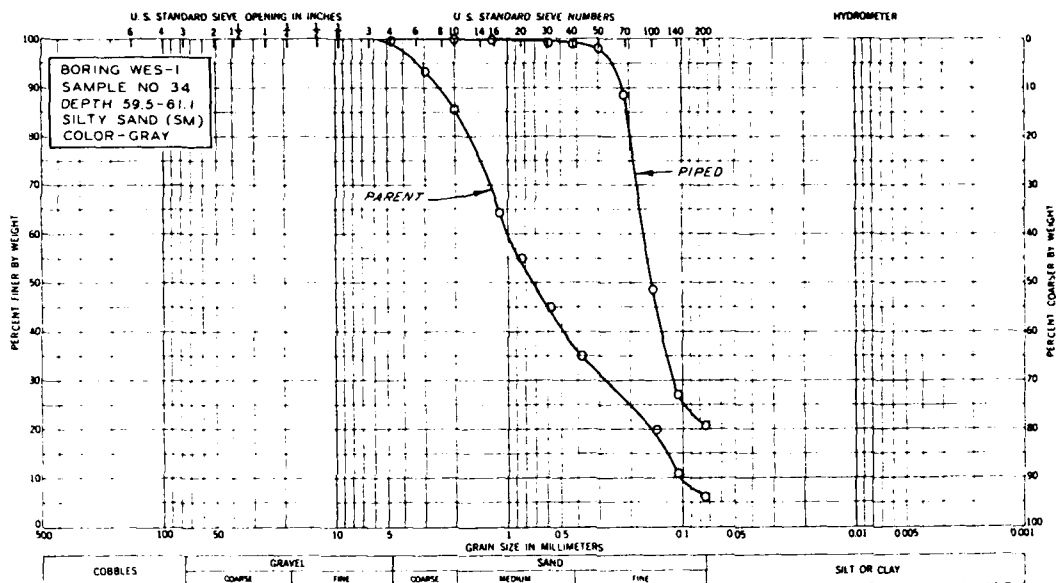
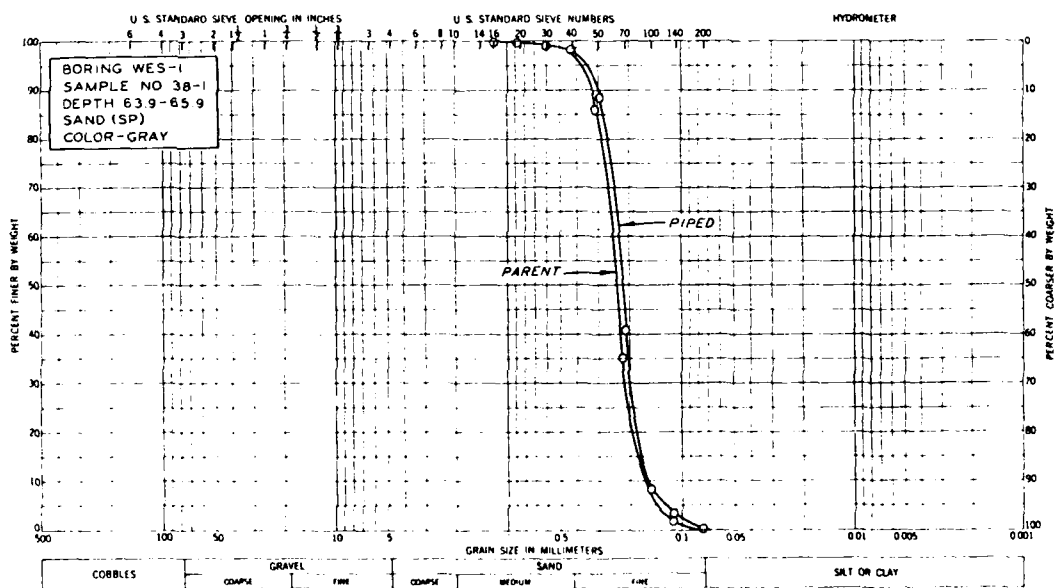
Figure 39. Comparison of parent and piped material gradation

- d. Piping susceptibility. Because of the heterogeneous quantities of sand, clay, and silt in the samples and variation in erosion, a quantitative scale of piping susceptibility for the sands and silts cannot be established. However, it was evident that the sands and silts readily piped under water pressures as low as 3/4 to 2 psi. This pressure is equal to a head of water of only 1.7 to 4.6 ft. The first sample tested was predominantly fine- to medium-grained sand and began piping rapidly under the low water pressure of 3/4 psi. The gradation of the piped material versus material left in the sample is shown for tests on sample WES-1-34 and WES-1-38 in Figure 39. The piped material gradation is similar to silty sand piped into the tunnel (Figure 24).

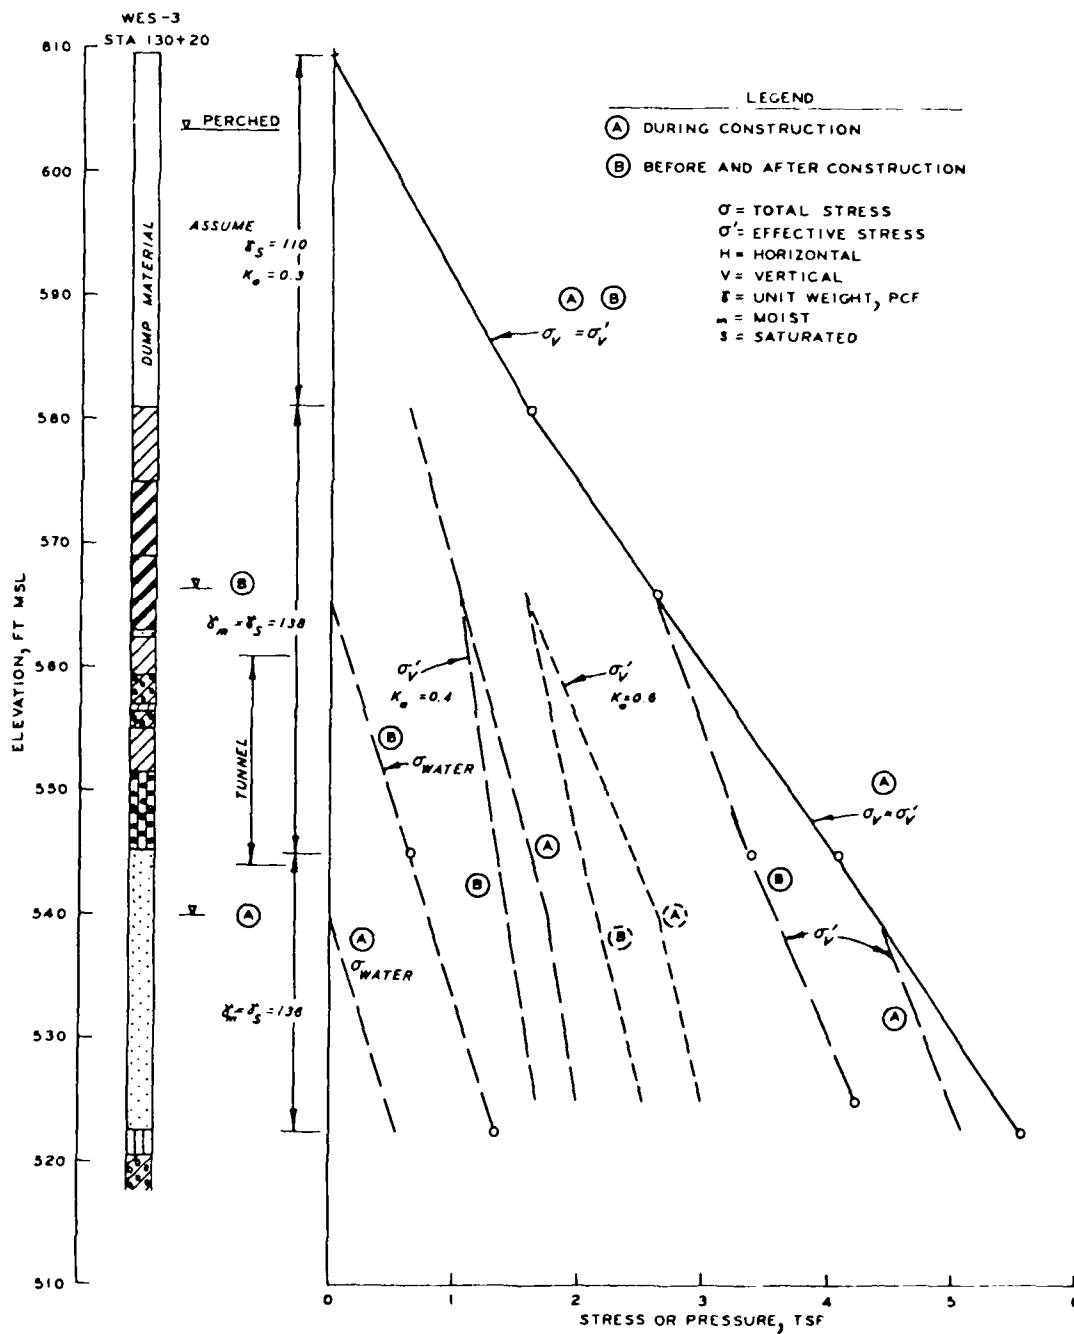
Figure 40. Estimated in situ soil stresses, Sta 130+20

71. In situ stresses. Vertical and horizontal pressures were estimated for two conditions on the basis of wet unit weights from undisturbed samples and K_o values from $K_o \bar{R}$ tests. The first condition, as shown in Figure 40 at boring WES-3, Sta 130+20 (just south of Distressed Area 1), is during mining with dewatering. The second is before and after construction when the water table returned to a

- a. Vertical pressures. Total vertical stresses are based on total unit weights. A perched water condition exists in the dump area and the water and material in the dump rest on the underlying soils as if contained in a bathtub. Drainage of the dump is prevented by the underlying plastic and impermeable clays. The perched water level is based on the log of boring TB-24 that showed fill with some debris to a 6-ft depth and that groundwater was encountered at the same depth (considered reliable because the hole was advanced with a solid stem auger to 10 ft and cased to 12.5 ft). The saturated unit weight of 110 pcf for dump material was based on the loose, caving conditions in boring WES-2 (para 60). Effective vertical pressures are based on submerged unit weights of soils below the water levels shown for conditions A and B. The artesian pressure acting in the beach sand unit is assumed for condition B to rise through the lean clay and sandy clay which is stratified with silt and sand seams. A similar plot of vertical pressure versus depth is shown in Figure 41 for Sta 112+81 (adjacent to Distressed Area 3). Vertical stresses are only about 0.3 tsf higher than at Sta 130+20 and the stresses shown for Sta 112+81 are representative of stresses at locations other than the dump area.

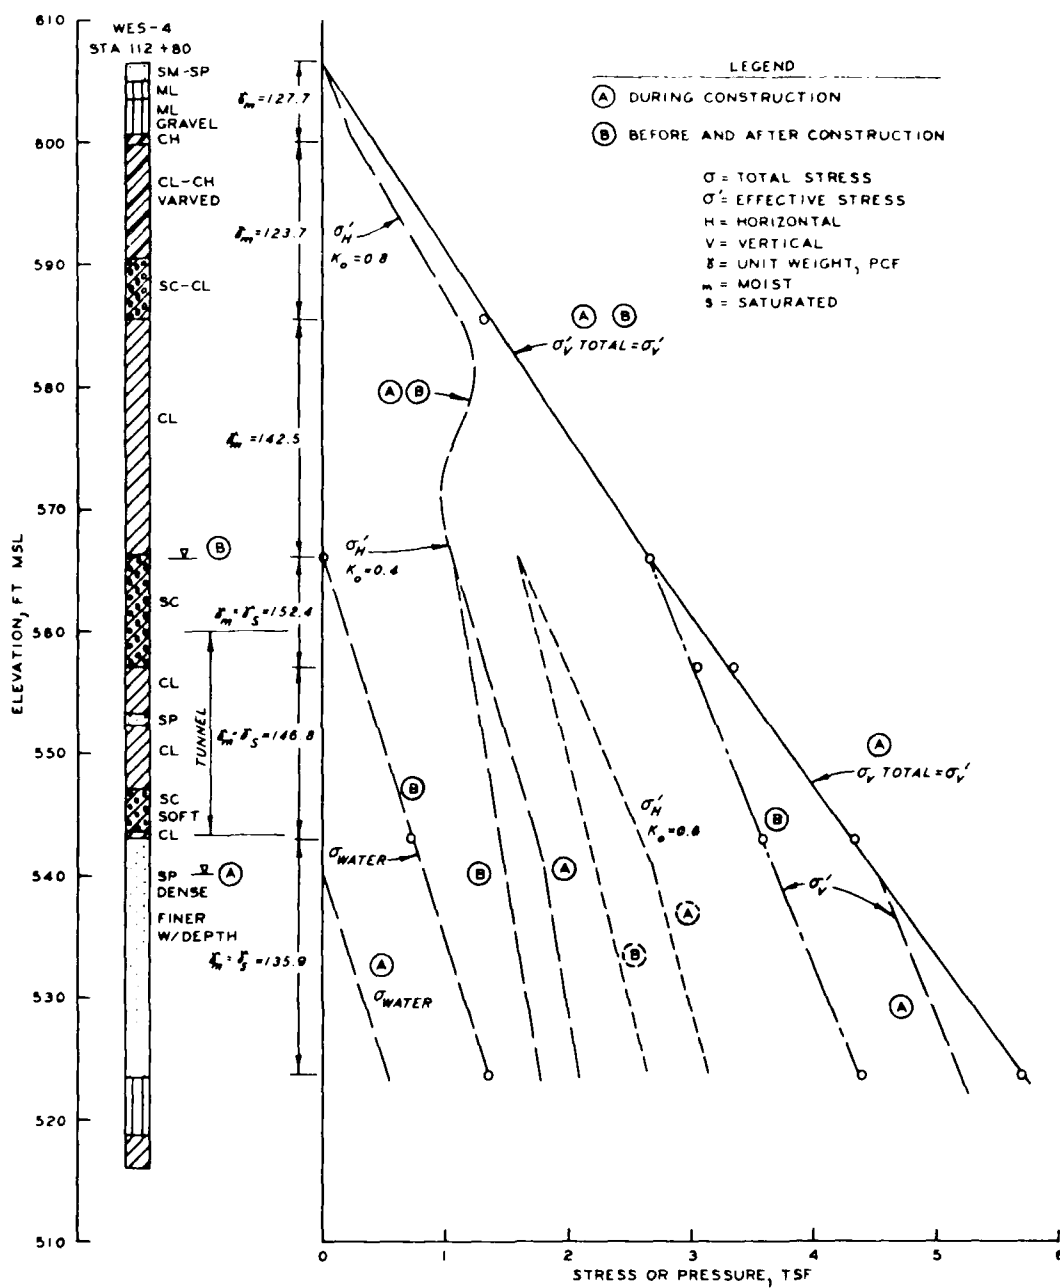
Figure 41. Estimated in situ soil stresses, Sta 112+80

- b. Horizontal stresses. Effective horizontal stresses are equal to K_0 (the effective stress coefficient of earth pressure at rest) times the effective vertical stress. The effective stress is equal to the total stress less the pore water pressure. For the drained condition with no pore water pressure during dewatering, the effective stress was taken as equal to the total stress. The values of K_0 shown in Figures 40 and 41 are based on the K_0 test results (Table 15) and K_0 values estimated from consolidation test data. The K_0 values are affected by stress release of ground pressure during sampling and may be low. Consequently, effective horizontal stress lines for an upper limit for K_0 of 0.6 are shown on Figures 40 and 41 to bracket possible values. A value of 0.65 was determined for very dense highly overconsolidated glacial till north of Toronto (Radhakrishna and Klym, 1974) and a value of 0.6 is considered an upper limit for the dense materials at the tunnel site. When total stresses are considered beneath the water table for saturated

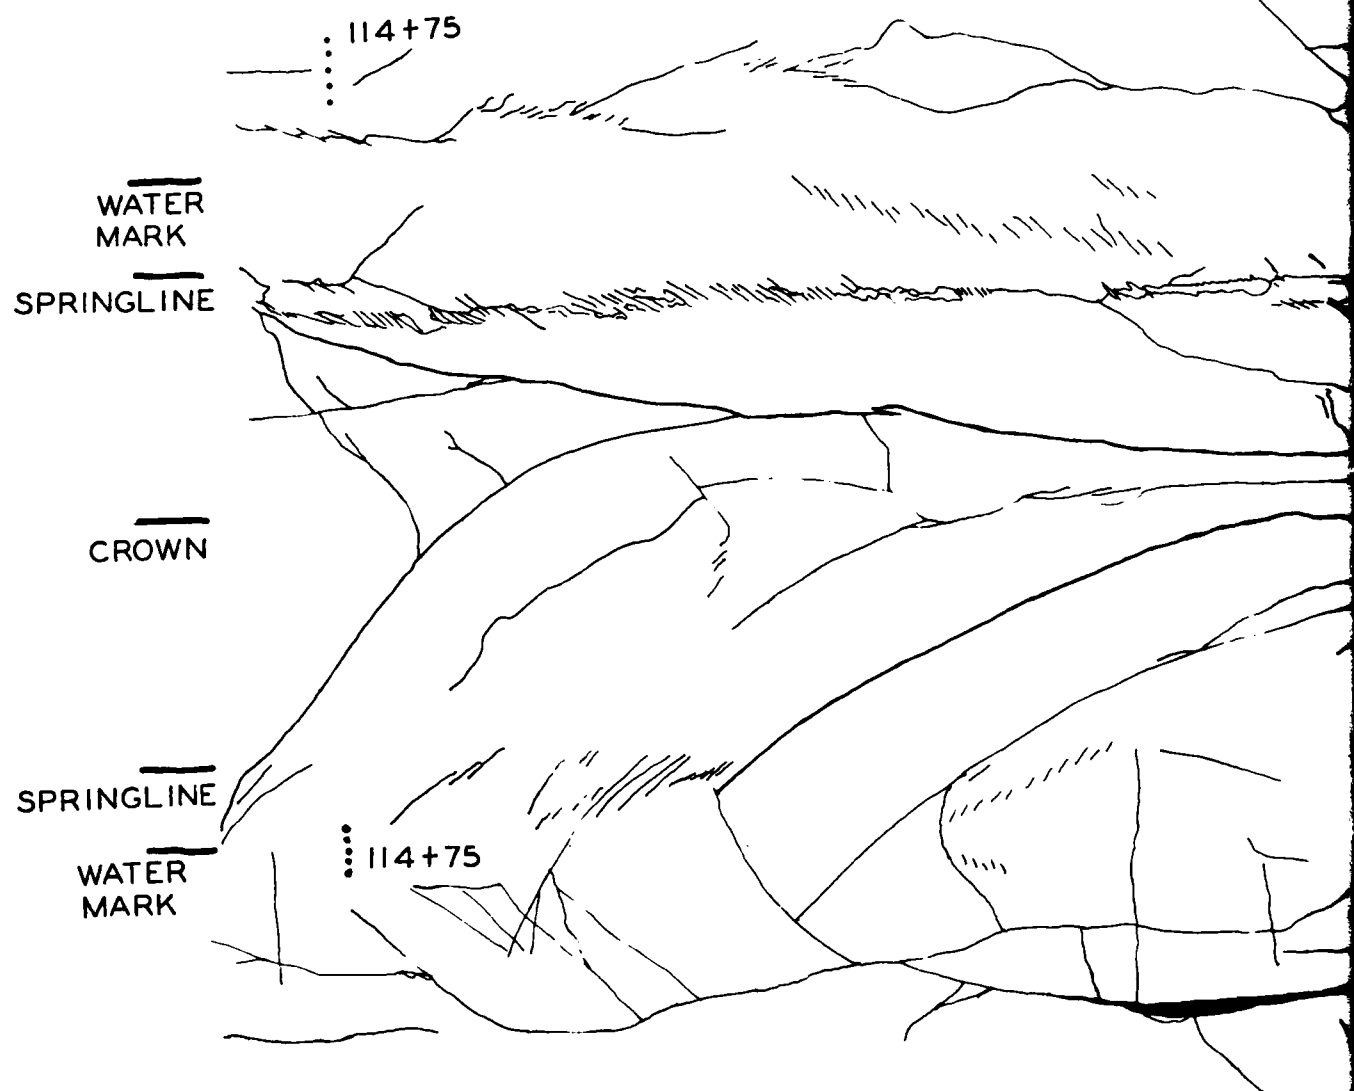
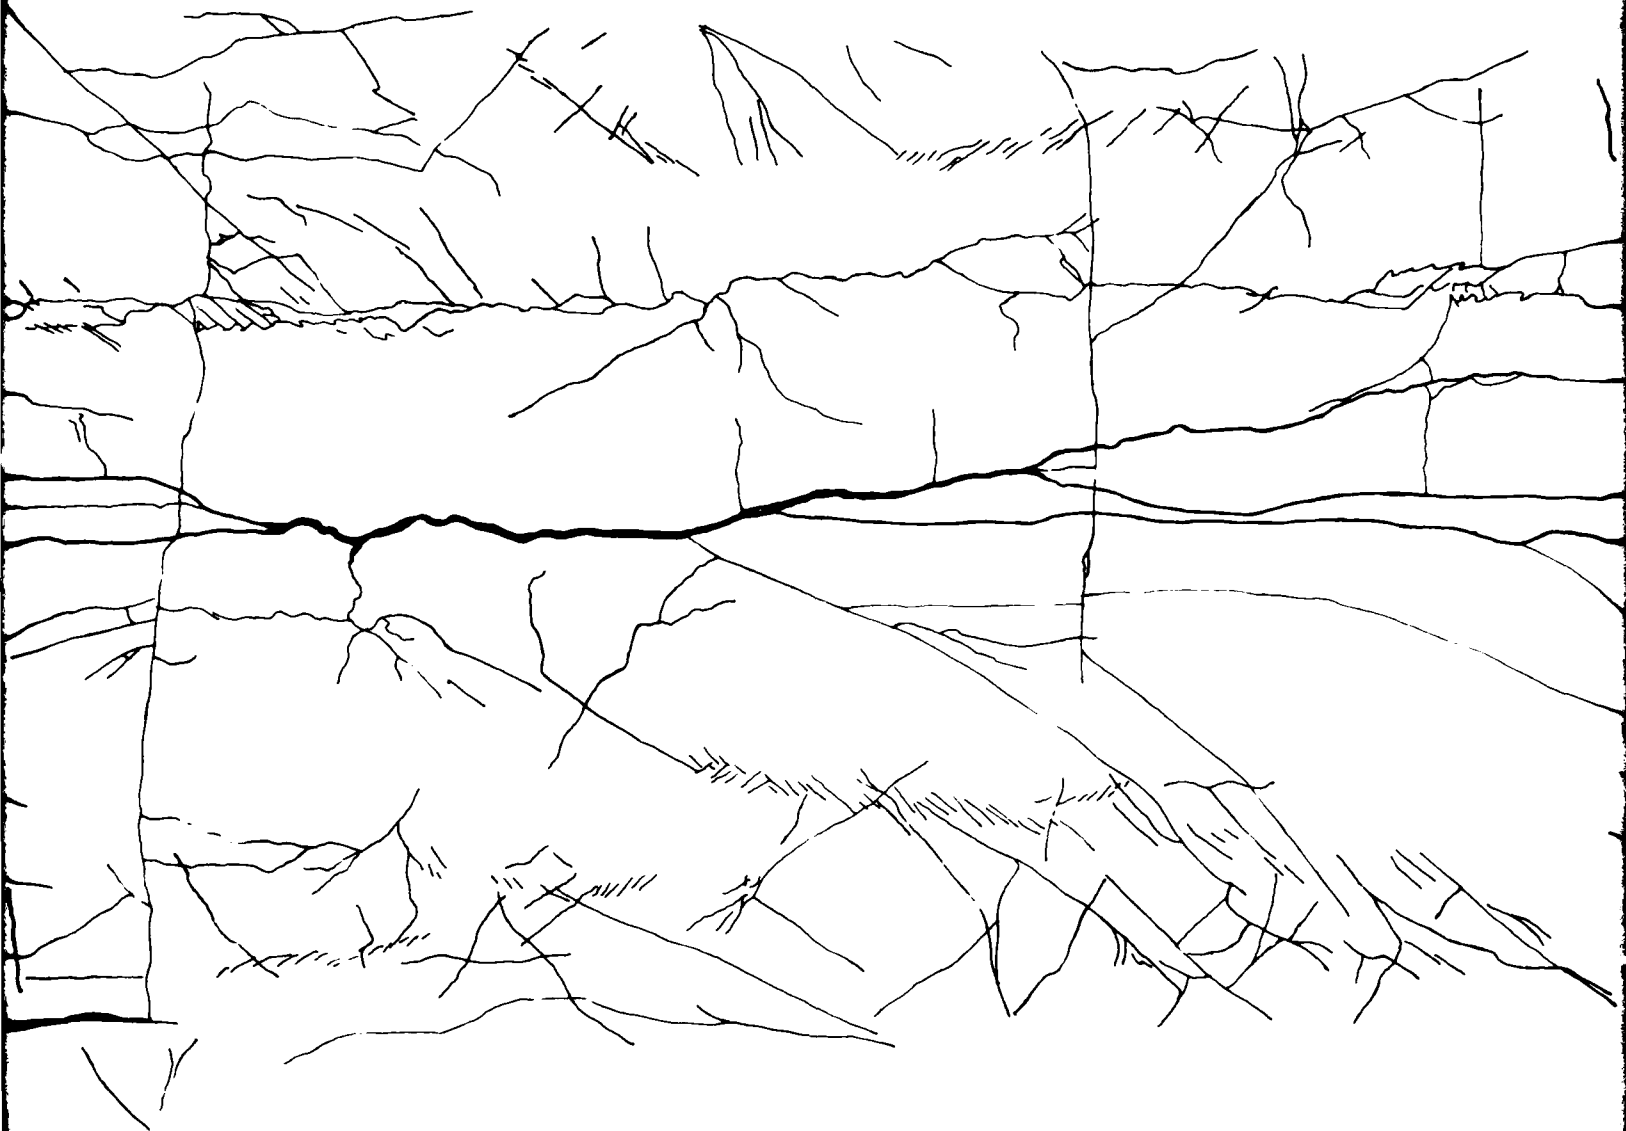
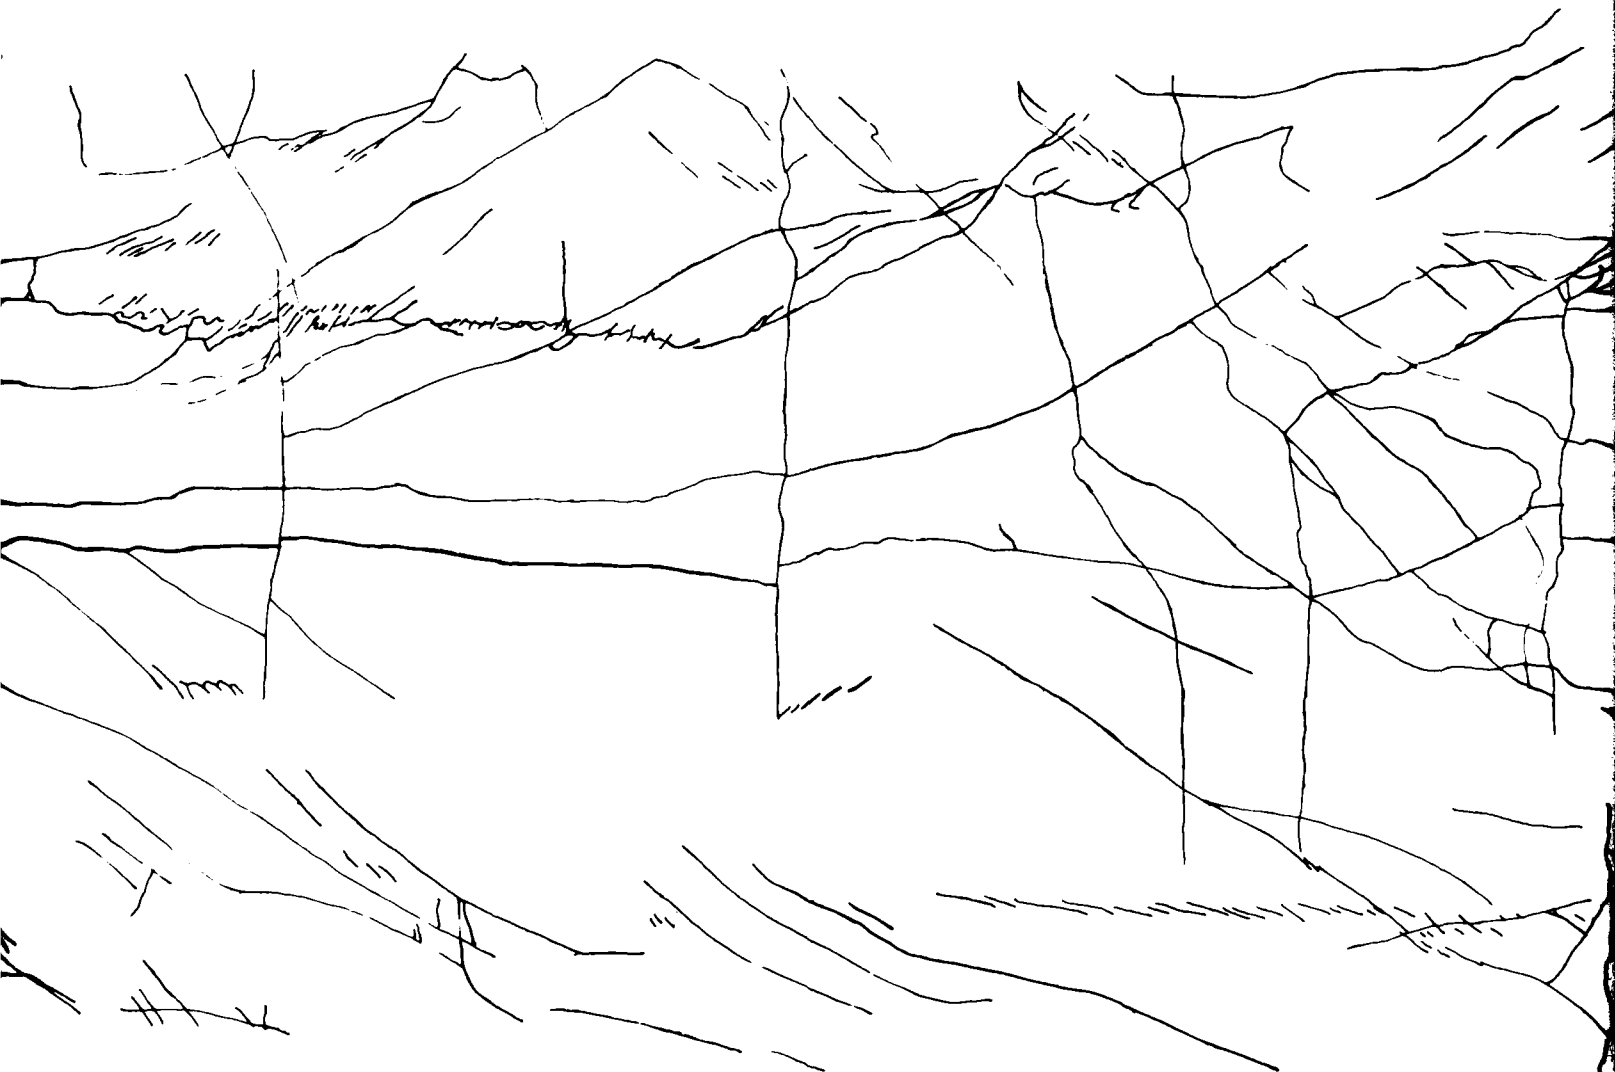
that existed at any location during this study. In order to obtain a composite view of the cracks, an overlapping series of 35-mm photographs were taken of the fractured surface area between Stas 113+25 and 114+75. This 150-ft section approximates Area 3. The photographs, which were taken at the invert, water line, springline, center line, and crown at each location, were put together in an overlapping manner to form a one-dimensional mosaic of the tunnel. Because of the photographic technique used to make the photo mosaic, the magnification of pictures near the invert was greater than that of the pictures made near the crown. The cracks in the photographs were then sketched on paper and scaled down to a more manageable size. The resulting crack pattern for Area 3 is shown in Figure 46. Insufficient photographs at Areas 1 and 2 prevented a complete mosaic compilation in those areas, but the patterns are similar to Area 3. The perspective in viewing Figure 46 is that the round culvert is drawn as if it were flat. The true orientation of the cracks can be obtained by rolling a copy of Figure 46 into a tube around the longitudinal axis of the tunnel and placing the crown or invert in the proper location. Figure 46 shows all forms of cracking, i.e., longitudinal, circumferential, and diagonal. Evidence of crushing at the springline also can be seen. The water line indicated is actually the water mark that existed at the time of the survey. It was very pronounced due to the collection of solid matter left on the wall.

46. Crack pattern, Distressed
Area 3

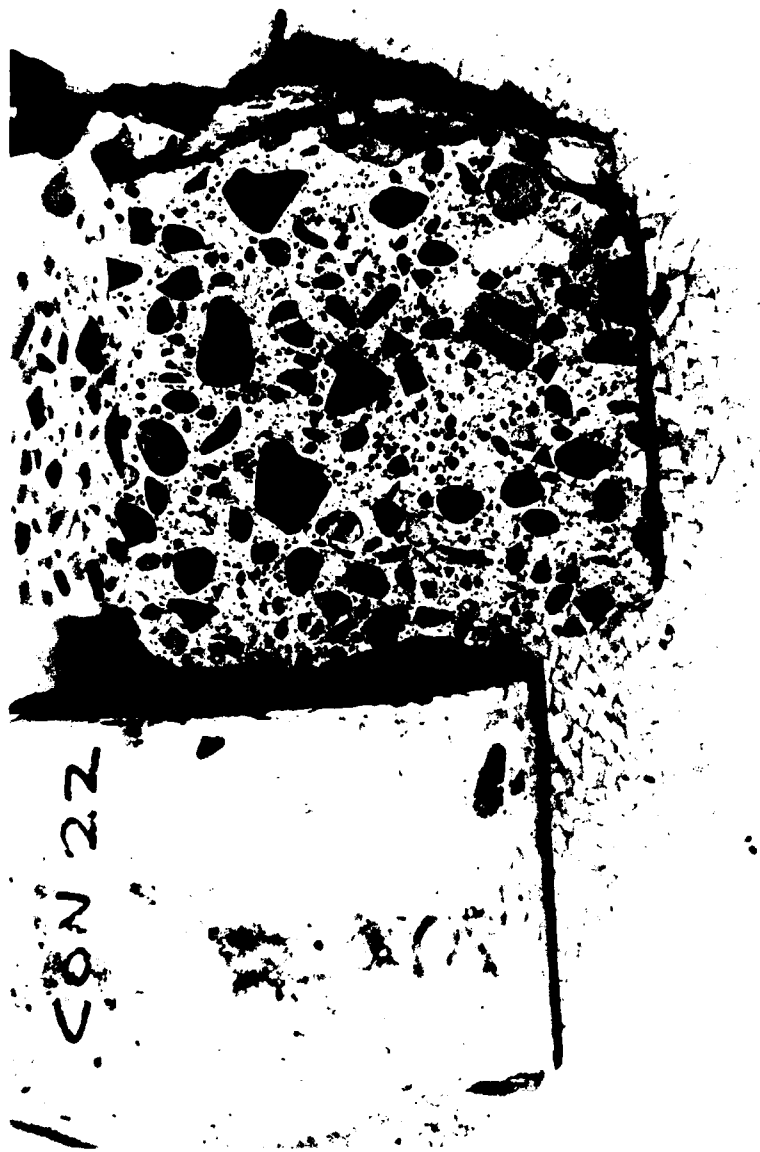
- (2) The concrete cores, with few exceptions, appeared to be well consolidated, homogeneous, and in good condition. The sawed and ground surfaces of cores from Stas 117+25 and 119+15 (nondistressed areas) shown in Figures 51 and 52, and Sta 133+13 (break area 1) shown in Figure 53 illustrate the appearance of the concrete. Visually, there is no significant difference in the appearance of the concrete in cores from either the distressed or non-distressed areas of the liner. One notable exception occurred in a piece of concrete recovered on 22 August 1980 by the Detroit District personnel during the

Figure 53. Similar surface as Figure 26, culvert floor core DET-4 CON-22,
Sta 133+13, in Distressed Area 1

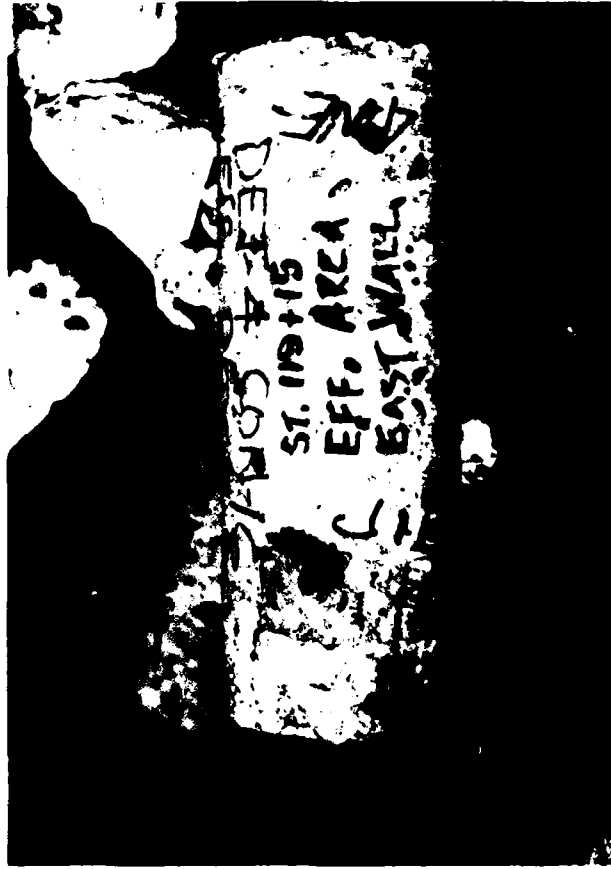
- (3) Portions of the samples noted in the previous paragraph along with material from a sediment inclusion in a core from Sta 119+15 (Figure 55) and sediment coatings on crack surfaces contained in the core from Sta 113+45 (Figures 47-48) were examined by X-ray diffraction. They all contained chlorite and clay-mica,* plagioclase feldspar, quartz, dolomite, and calcite. There were traces of vermiculite and kaolinite. The samples from Stas 114+40 and 120+71 also contained a little potassium feldspar, amphibole, and magnetite. The sample from Sta 114+40 contained a trace of gypsum. In general, all four samples were similar in composition and can be considered as a soil. Some of this soil had been included in the concrete during construction (Figures 54-55) and some had entered through cracks in the concrete (Figures 47-48).

Figure 55. Six-in. diameter culvert wall core DEE-4 (Cell-16); it was drilled over the cold joint where it showed efflorescence and a sediment inclusion; Sta 119+15 nondistressed area

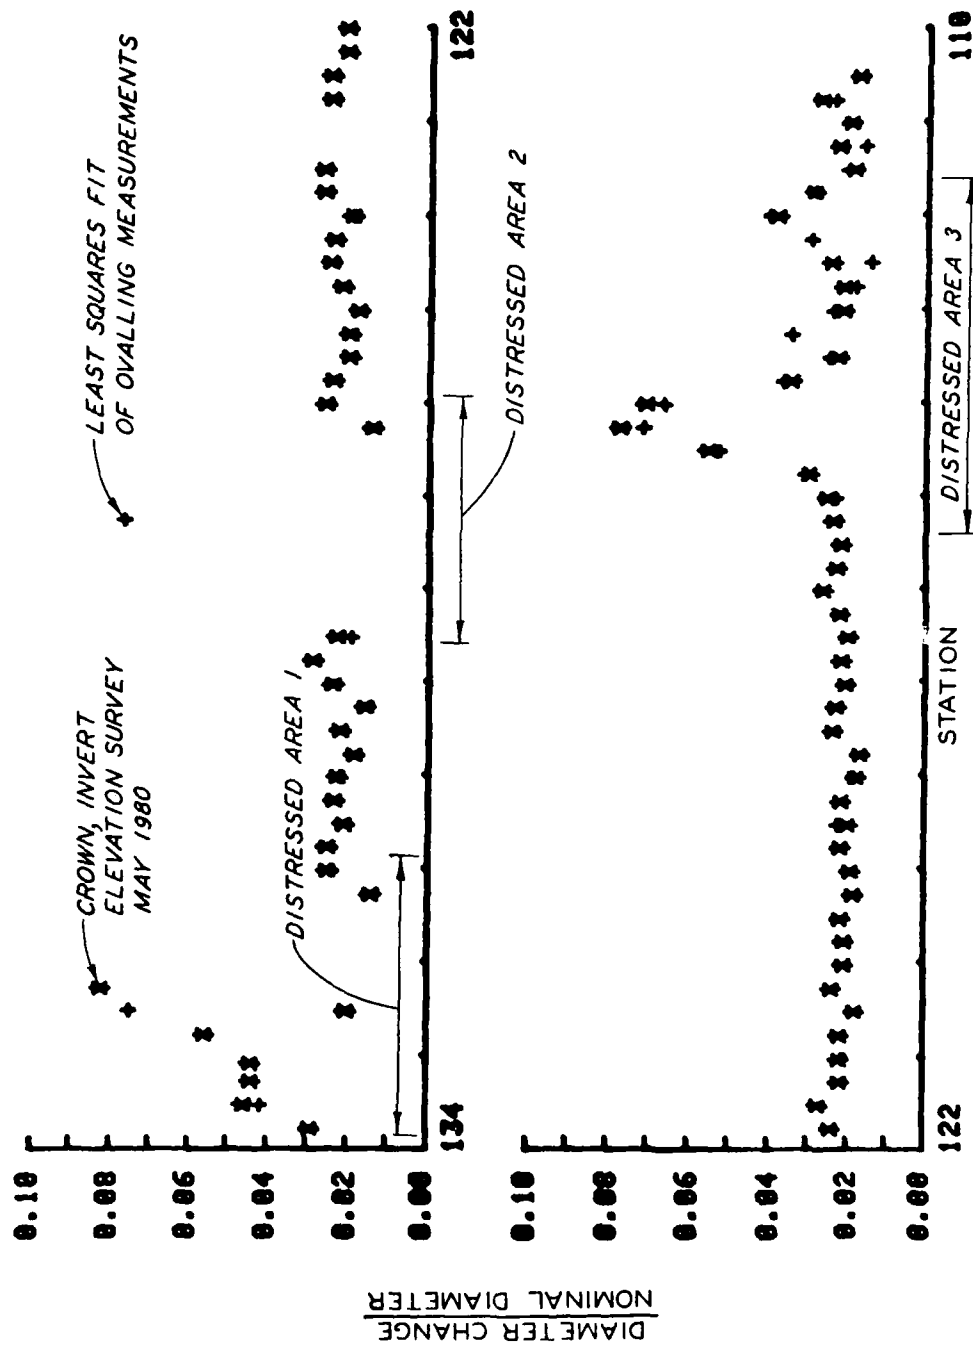
83. The deformation of the sewer tunnel along its length following its failure is depicted in Figure 60. The figure shows the difference between the structure's nominal 12-ft-9-in. inner diameter and the crown-invert diameter as a fraction of the nominal diameter. The points indicated by asterisks in this figure are based on a survey of crown and invert elevations performed for the Detroit Water and Sewage Department by the firm of Hubbell, Roth, and Clark in May 1980. It is notable that the crown-invert diameter was compressed to a value as much as 8 percent less than the nominal diameter in the distressed areas of the bypassed section. The consistent 2 percent compression of the crown-invert diameter in the nondistressed areas is probably

Figure 60. Owalling profile

attributable to inner form out of roundness and deformation during construction of the tunnel.

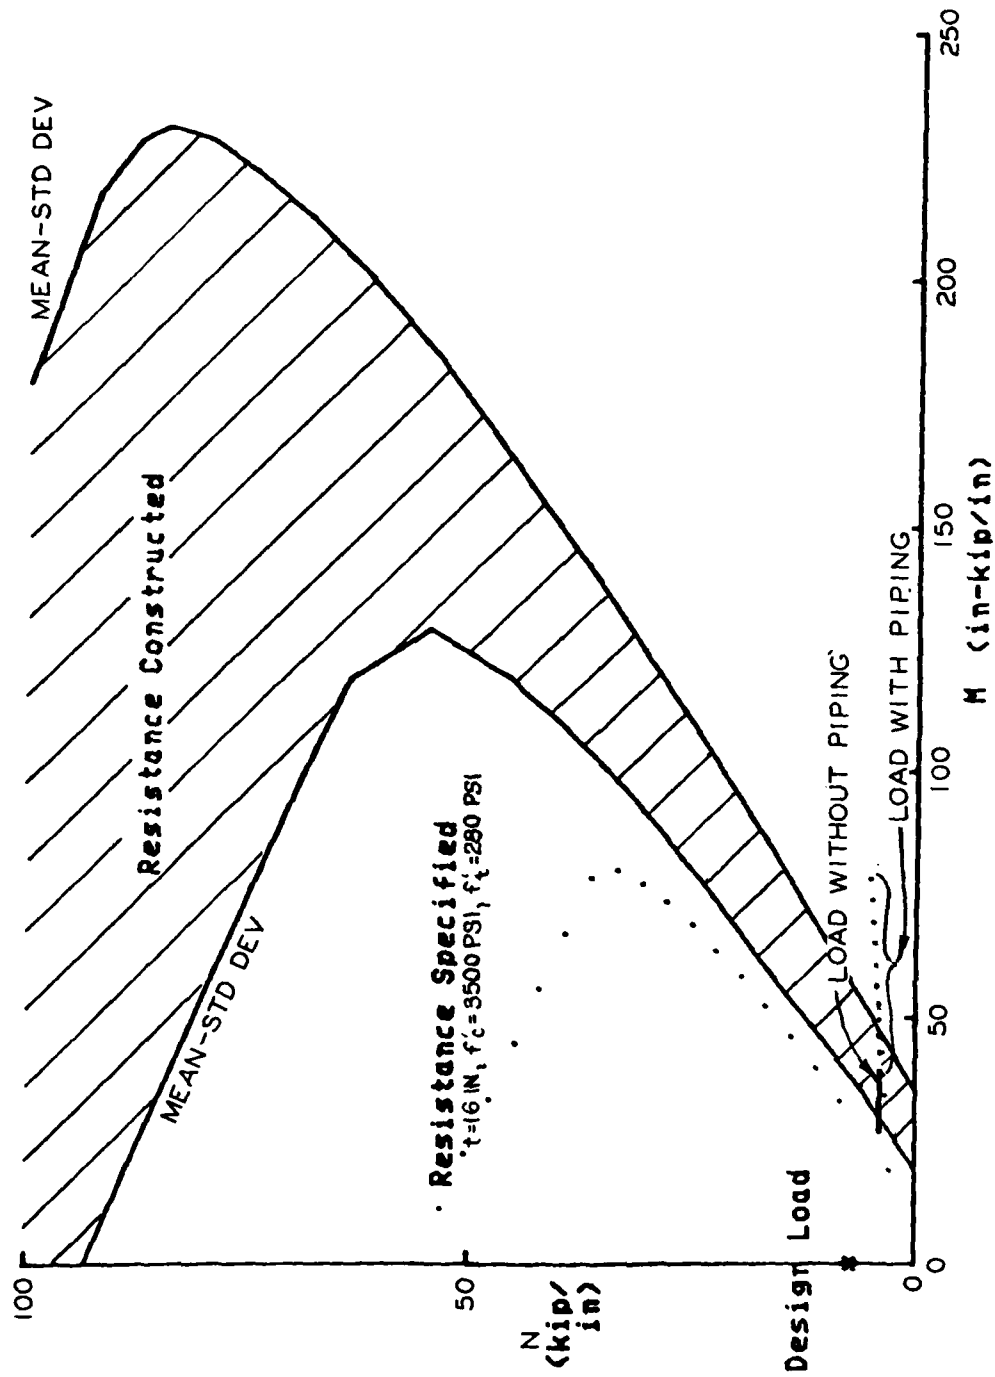
Figure 65. Structural reliability of concrete lining under external pressure

102. These critical moment and thrust loading combinations are connected by a dotted line on the previous plot of resistance curves in Figure 65. This range of loadings suggests that piping of material near the invert would probably not directly cause the collapse of the constructed tunnel system. Such piping could possibly initiate the structural failure of the concrete lining in the weakest areas of the sewer. However if such a failure did begin, it is again believed that the subsequent interaction among the concrete lining, primary lining, and the competent soil material remaining adjacent to the springline could have prevented the severe structural failure of the tunnel which did occur in some areas.

103. In contrast, Figure 65 suggests that the piping of material near the springline would be expected to initiate the structural failure of the concrete lining in even the strongest areas of the

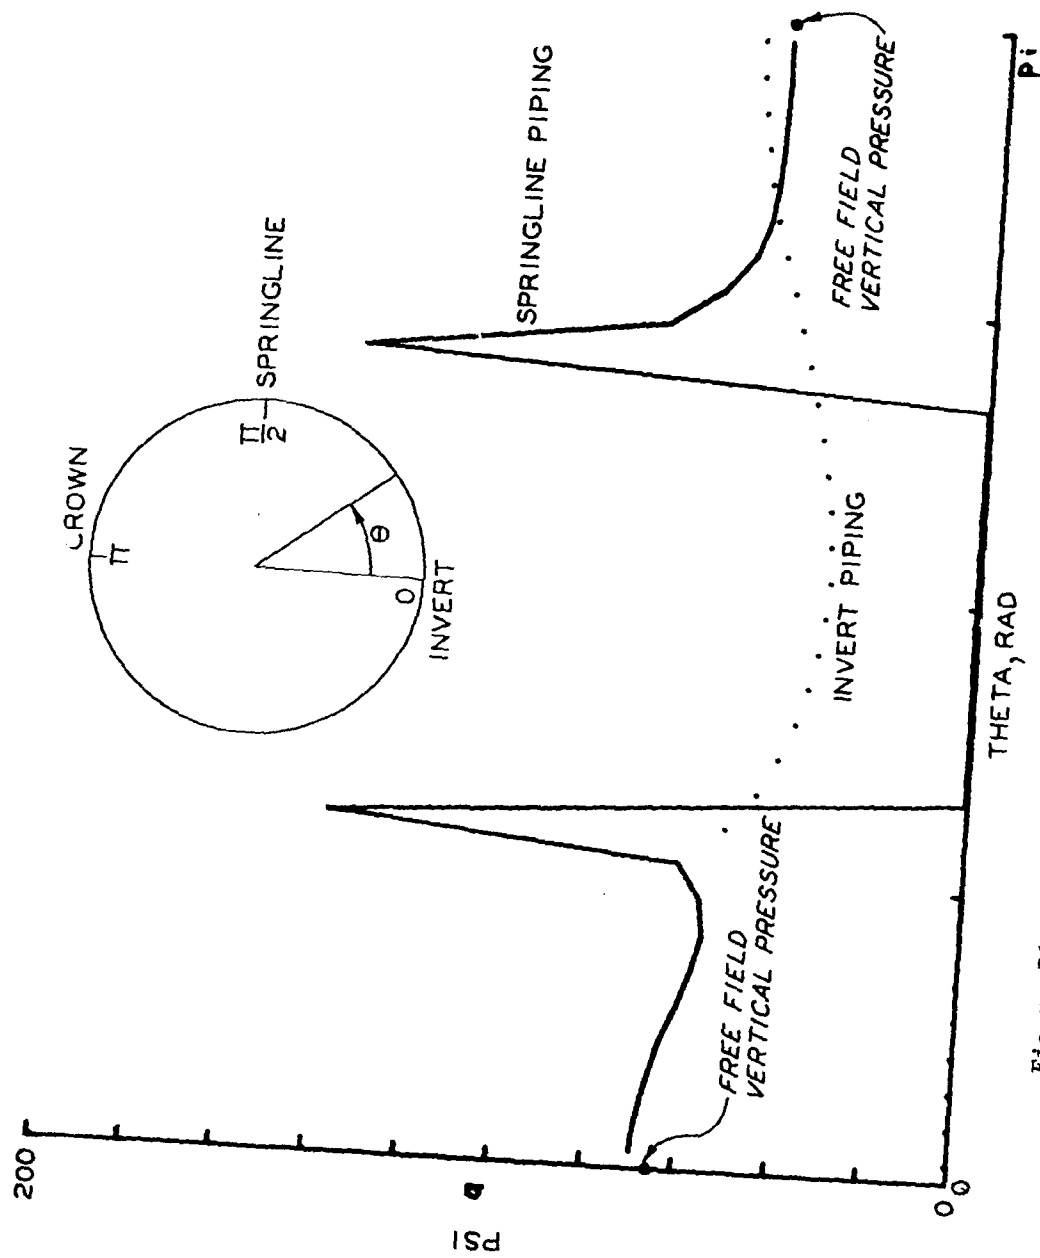
Figure 76. Pressure distribution on tunnel liner; piping

101. The results of these analyses are summarized in Figures 76 through 79. In both cases the interface pressure q and the shearing stress τ across the structure medium interface are seen to be markedly nonuniform near the voids assumed to be caused by piping. The effect of this loading on bending moment M and axial thrust N is not particularly harmful for the case of a void under the invert. In this case the regions in which the tunnel's inner surface is stretched or compressed change from the unpiped cases, but the severity of the critical moment and thrust combination does not change appreciably from these unpiped cases. On the other hand, if a void occurs near the springline, the severity of the critical moment and thrust combination increases dramatically from the unpiped case. In this case the inner surface of the tunnel near the springline is compressed while the corresponding surfaces near the invert and crown are stretched. This pattern of deformation is similar to the distressed condition existing in the tunnel which has been previously discussed in paragraph 82.

sewer. If such a failure did initiate, some of the loading would attempt to transfer from the concrete lining to the primary rig and lagging lining. However, lacking any competent soil material adjacent to the springline with which to interact, this flexible primary lining would have little capacity to sustain this loading. Eventually, as severe a collapse of the tunnel as did occur in the distressed areas could be expected.

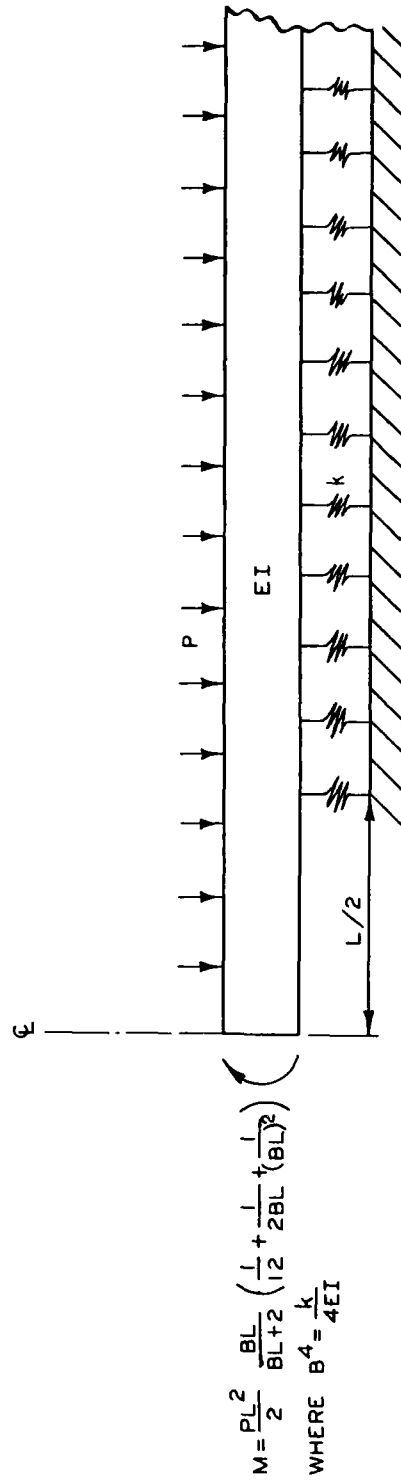
Figure 80. Longitudinal bending of concrete lining by loss of foundation support

104. One additional stress analysis was conducted to assess the effect of a continuous void extending longitudinally along the invert due to extensive piping of material. In this analysis the concrete lining was modeled to be an infinitely long flexural beam of rigidity EI as shown in Figure 80. The beam is loaded by a uniform pressure p corresponding to the weight of the overburden material above it and it is supported by an elastic foundation whose modulus k represents the stiffness of the soil material on which it rests. A void of length L exists under the beam to model a complete loss of support due to piping of surrounding material. Using the methods described by Timoshenko (1930), one can derive the expression given in Figure 80 for the bending moment M imposed in the beam at the center of the void. This moment would tend to crack the lining circumferentially rather than longitudinally as would the previously discussed moments induced by nonuniform external pressure.

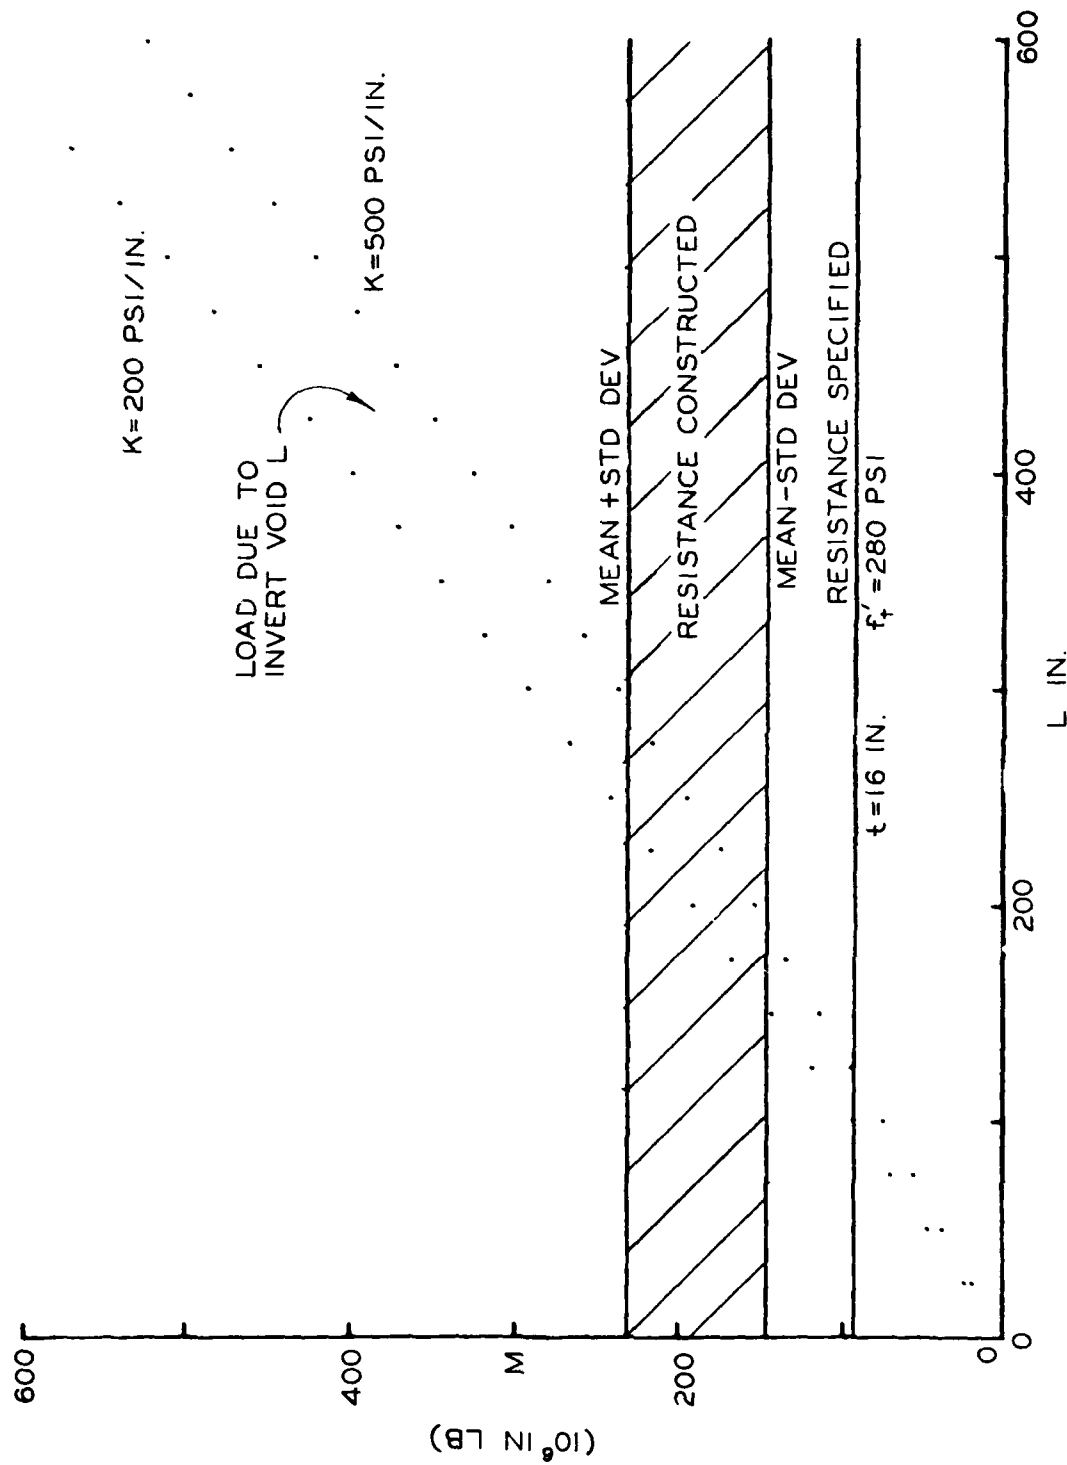
Figure 81. Reliability of concrete lining in longitudinal bending

105. Figure 81 shows the magnitude of this bending moment M as a function of the void length L . It was drawn for the springline overburden pressure $p = 7800$ psf previously computed in Figure 41, for a lining modulus of elasticity $E = 6 \times 10^6$ psi and for a moment of inertia $I = 3.06 \times 10^7$ in.⁴ corresponding to a hollow circular cylinder with inner and outer diameters equal to the nominal values of 153 in. and 185 in. The effect of foundation modulus variation between $k \approx 200$ psi/in. and $k = 500$ psi/in., which bracket the stiffness of the material under the tunnel, is also illustrated in this figure.

resistance is approximated by the product of the concrete tensile strength and the elastic section modulus of the tunnel in longitudinal bending. Accordingly, for the contract-specified 16-in. wall thickness and concrete mixture discussed in paragraph 89, the resistance to longitudinal bending is approximately 93×10^6 in. lb as shown in Figure 81. The distribution of resistance in the lining as built depends on the distribution of wall thickness and tensile strength constructed. Using the Monte Carlo technique and the assumptions previously described in paragraph 91, it was estimated that the resistance of the majority of the concrete lining is contained within the hashed region of Figure 81. It is seen that the constructed lining has a resistance to longitudinal bending which generally exceeds that implicitly specified by the contract. It is further observed that the loss of foundation support due to invert piping for a longitudinal distance on the order of 200 in. could cause the tunnel to fail in longitudinal bending. This event would be accompanied by a circumferential cracking similar to that described in paragraph 73 near Distressed Area No. 3.

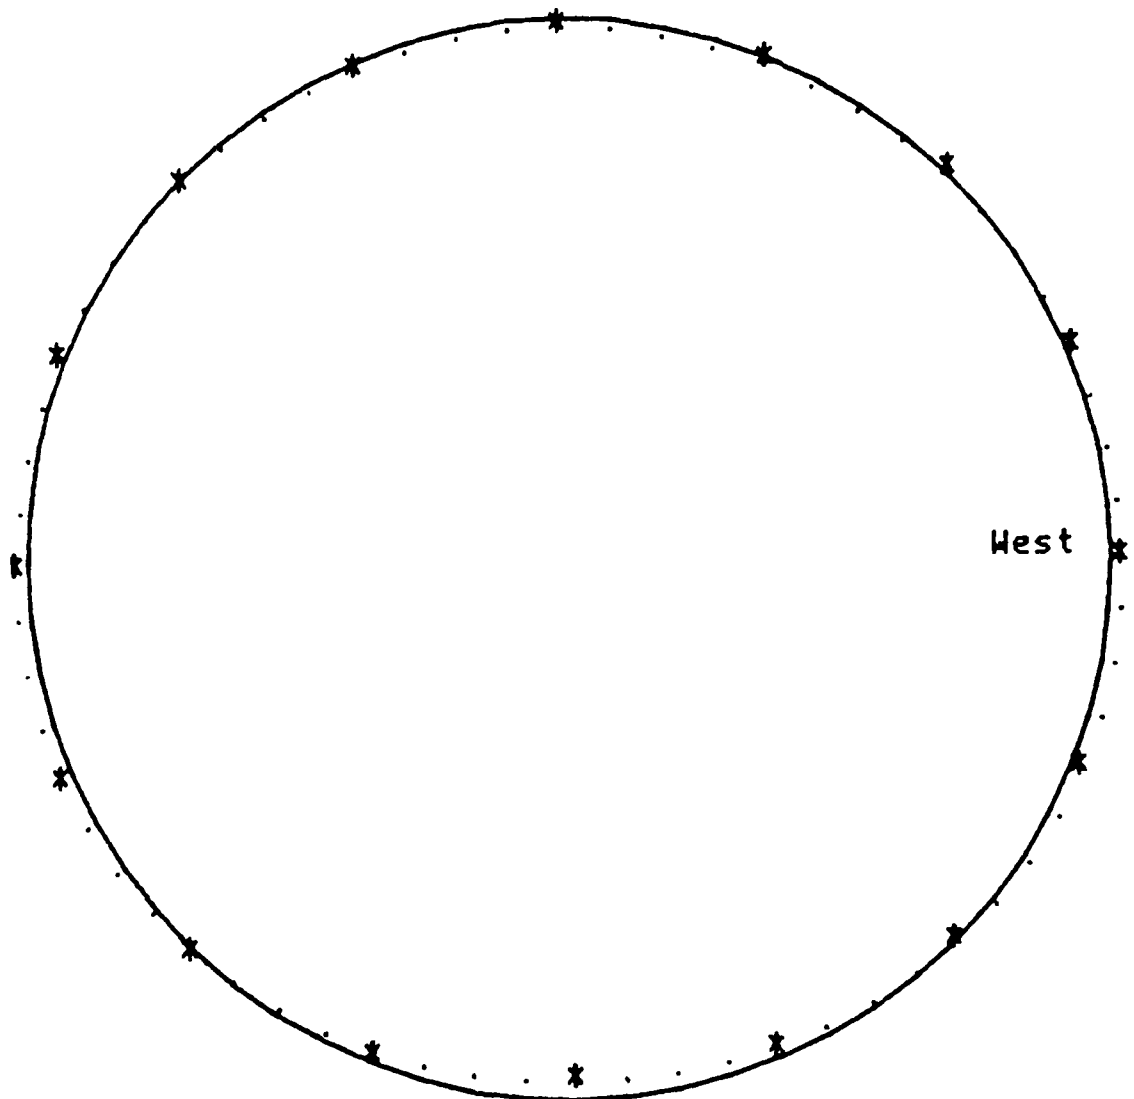
PCI-7 STA 113+00

$w/r = 0.0238$

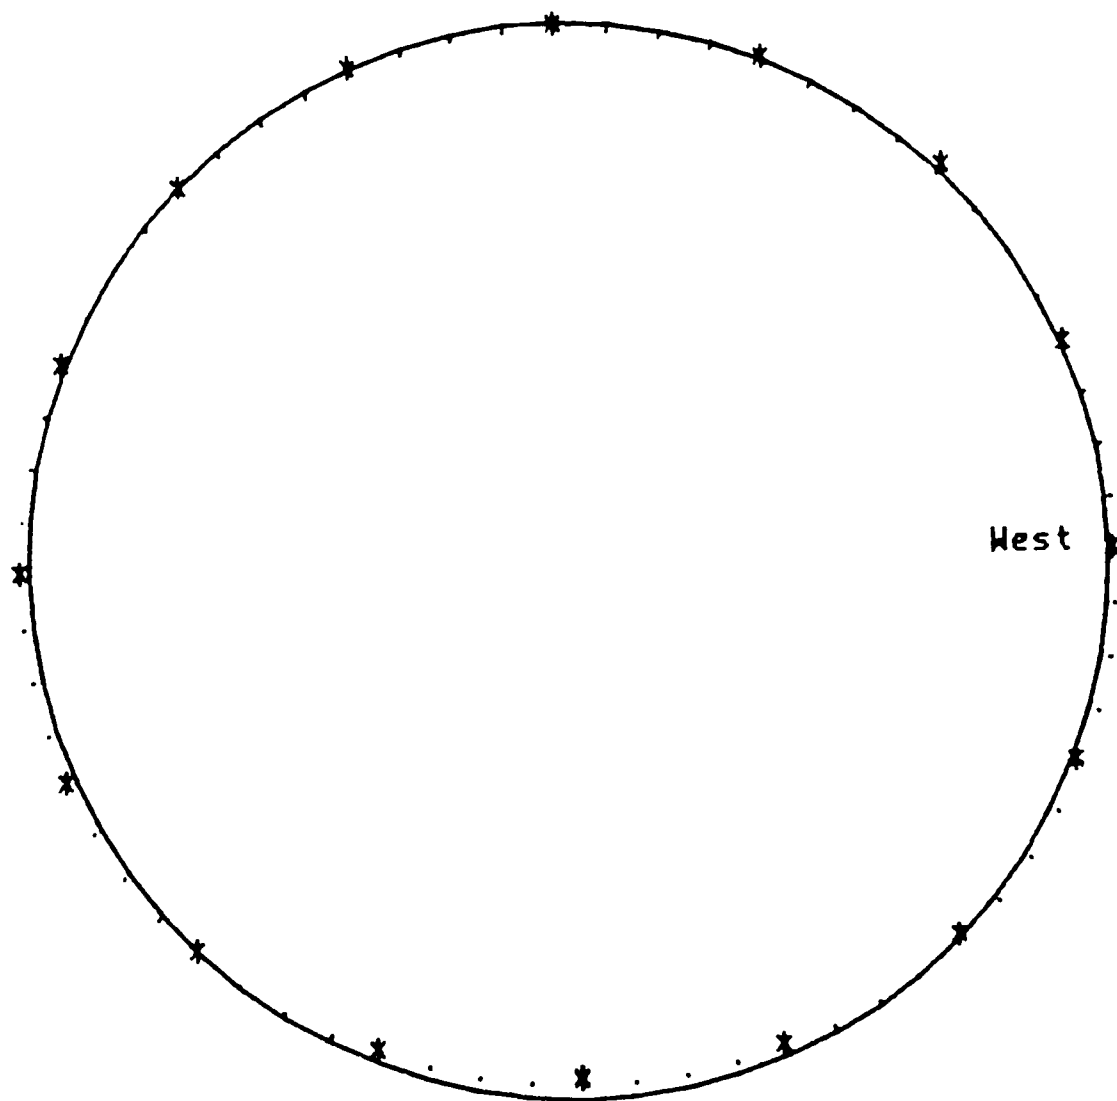
PCI-7 STA 112+75

w/r = 0.0180
